CONSERVATION DELEMMAS – THE FATE OF THE TIMBER ORTHODOX CHURCH IN MIĘKISZ STARY

Jan Kurek

Krakowska Akademia im. A.F. Modrzewskiego
Wydział Architektury

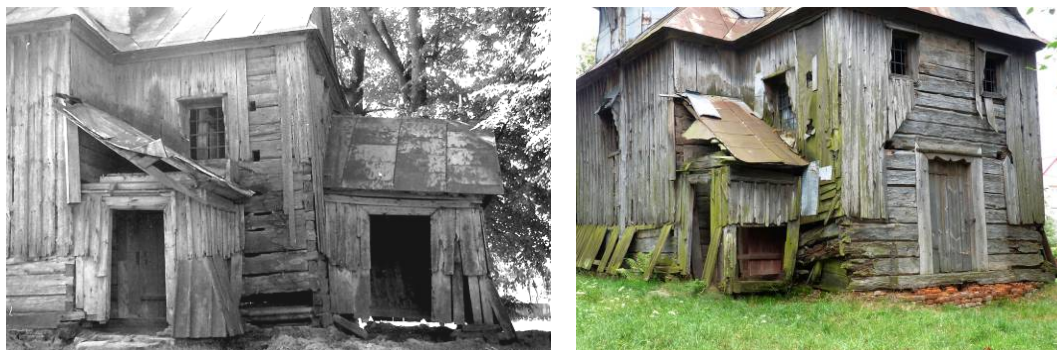
Fig. 5. Mięgisz Stary, progressive degradation of the church's construction structure: state in 1989 (left) and existing state in 2015. Source: photo by author

The Orthodox church in Mięgisz Stary was built probably around 1801, at the site of an earlier Orthodox church, described in an inspection report as an "Orthodox church prone to collapse...". The structure's technical condition was considered poor in 1989 —there were leaks in its steel sheet roof cladding, which was damaged by gunfire during the First World War, and which caused considerable local damage to the timber structure of the ceiling and the walls, the foundations and some of the corners of the walls lost their initial form and stability, some of the boarding of the walls, along with a small roof protecting the bottom part of the walls from rainfall, sustained damage. The polychromes on the walls and dome in the interior were also significantly damaged. The structure's technical condition deteriorated even further in the years that followed.
